Manhole Inspection Summary

Manhole # S61K__013MH

Insp Date: **7/8/08 11:53 AM**

Location Address: **rear 902 s ponca st**

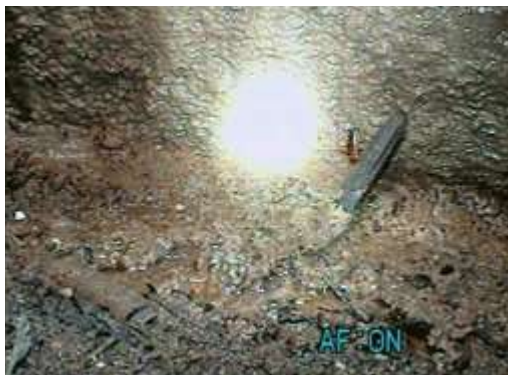
misc

bench debris

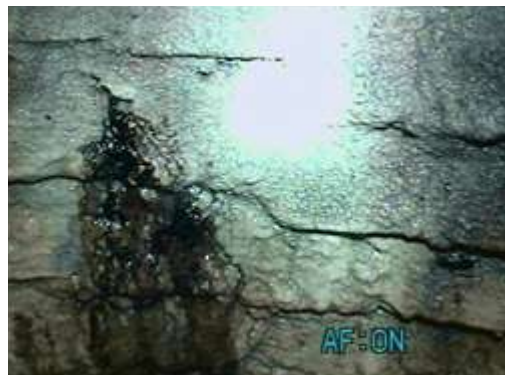
Defect 4

Infiltration: ☐ None ☐ Joint ☐ Cracks ☐ Mortar ☐ Roots ☒ **Wall**

barrel infiltration

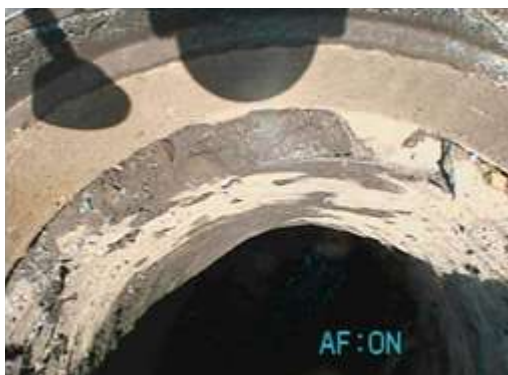
Defect 2

Frame Offset: **2** (in.) Condition: ☒ Sound ☐ Cracked ☐ Leaks

frame offset

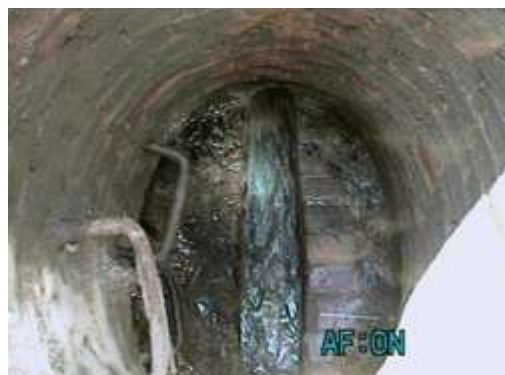
Defect 3

Steps Count: **3** Missing: **0** ☒ **Corroded**

Corroded steps

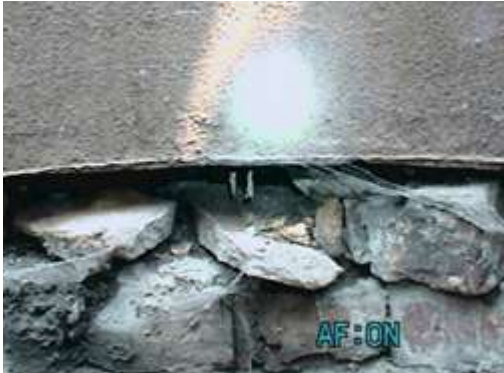
Defect 1

Condition: ☐ Sound ☐ Cracked ☐ Root Intrusion ☒ **Loose Brick** ☒ **Deteriorated**

loose bricks corbel

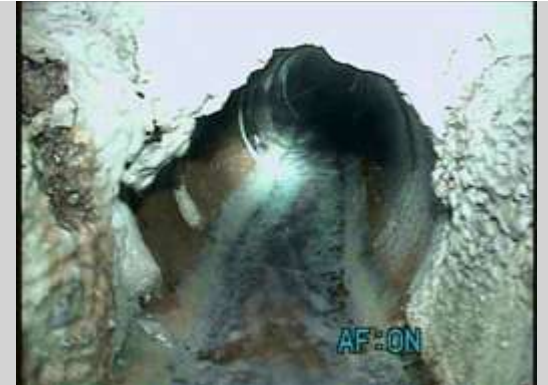
12 O'Clock Outflow

8 in. Circular Gravity Sewer
Pipe Out @ 12 O'Clock

Pipe Material: **Clay** ☐ Pipe Lined

Invert Depth: **8.40** (ft.) Flow Characteristics: **Fast**

Infiltration: **None** Pipe Seal Cond: **Unknown**

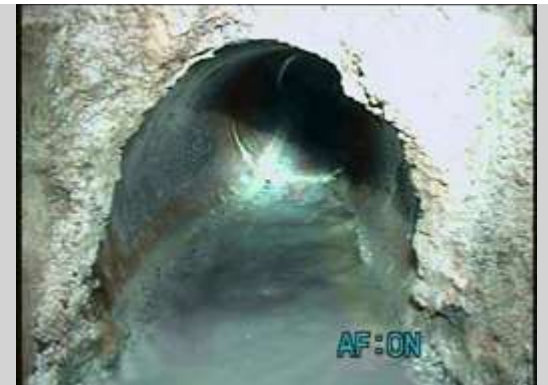
6 O'Clock Inflow

8 in. Circular Gravity Sewer
Pipe In @ 6 O'Clock

Pipe Material: **Clay** ☐ Pipe Lined

Invert Depth: **8.00** (ft.) Flow Characteristics: **Fast**

Infiltration: **None** Pipe Seal Cond: **Unknown**
